Electrical Accident Investigations Case Studies

Date: 2 March 2007

Presented by: Mr Caleb Seow
Engineer
(Electricity Inspectorate)

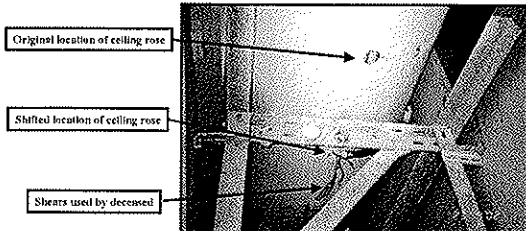
Appendix I - Inside view of the pillar column (C2309)

- The pillar column C2309 was surrounded by steel brackets and covered with stone cladding (see Appendix III). The working area was confined and humid.
- 2 sets of 3 cables were identified. The cables were housed in a length of PVC flexible conduit. The PVC flexible conduit was terminated into the ceiling rose base and these cables were drawn beyond this ceiling rose ready to be cut, fitted and terminated.

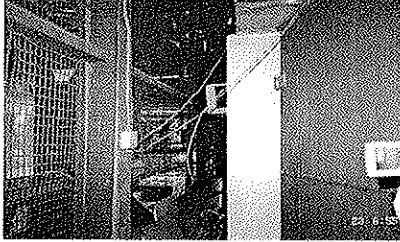
View of the 13A two-gang socket-outlet that supply electricity to the aluminium container (behind aluminium container)

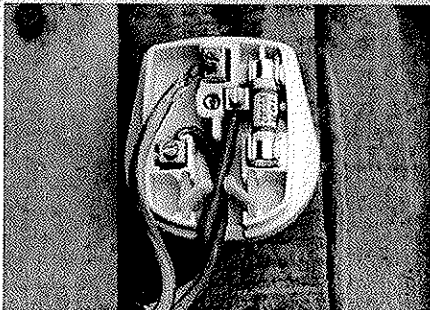
Photo No. 6

Earth conductor dislodged from terminal

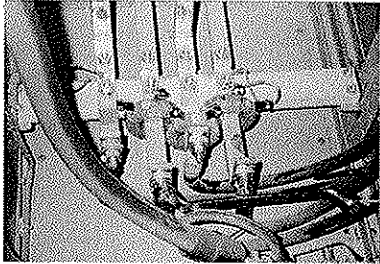
Photo No. 2

- A ring spanner was found in electrical contact with the blue phase outgoing terminal of the 300A MCCB catching on to a hexagonal nut
- Patches of burned human tissues were found stuck at the red phase outgoing terminal of the 500A MCCB

Ring spanner

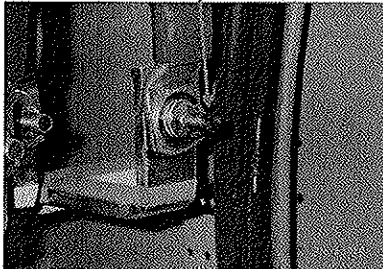
Photo No. 3

- The deceased could be tightening the nut securing the last CT when his left shoulder accidentally came into contact with the exposed 'live' (red phase) outgoing of the 500A MCCB
- The other parts of his body were in contact with the metal frame of the panel and formed a return path for the current to flow through his body and received a fatal electric shock
- Appropriate actions were taken against the offender

Patches of burned human tissues stuck at the red phase outgoing terminal of the 500A MCCB

- The 500A MCCB should have been switched off while work was being carried out on the 300A MCCB
- If switching off the 500A MCCB was not possible, insulating barrier should be used to cover the 'live' outgoing terminals of the 500A MCCB
- The holder of the electrical installation licence should inform his appointed LEW so that the necessary safety measures could put in place before commencement of work.
